## Aluminium Zinc Substrate Performance

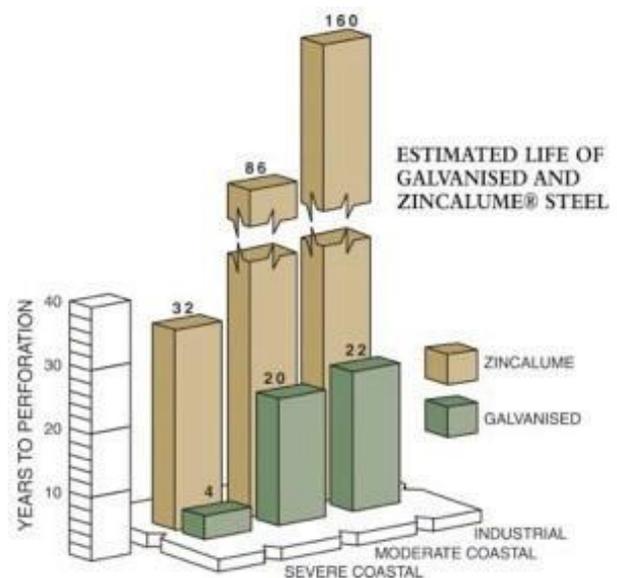
Figure 1

Edge or scratch damage corrosion spots are protected by the zinc that is close to the damaged area as well as the little understood small cathode/ large anode principle where little corrosion occurs to an edge of steel (small cathode) in the present of a large galvanic coated surface (large anode). This also helps explain why nails (galvanised) that have little protection from the elements remain in good condition for so long.

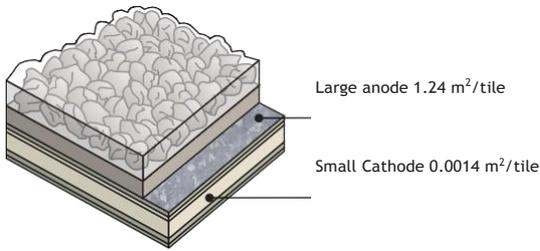
**Gerard Roofing coatings**

Roofs coating systems allow the natural reactions of the galvanic coatings to occur without effecting the protection offered to cut edges or scratches.

The acrylics used are not totally impermeable to oxygen or water vapour transfer and as such allow the reactions to take place, but they do however reduce the loss of the protective oxides and as a result prolong the life of the substrates.

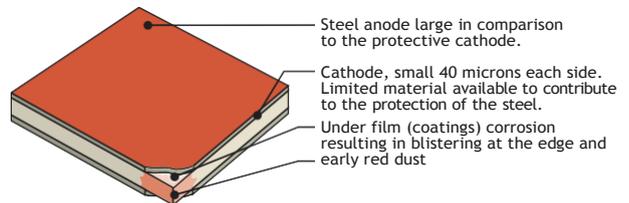
**Painted Surface**

The protection offered by Roofs coatings systems lays in their ability to maintain the highest possible anode (galvanic surface area) / cathode (small cut edges) ratio as physically possible. Other coating finishes reduce this ratio, increasing the rate of galvanic corrosion where steel is present.

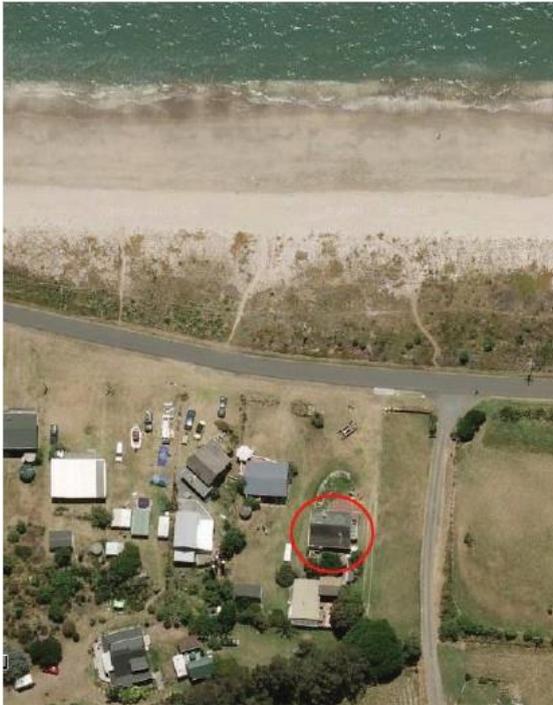
Roofs have had Aluminium Zinc tiles on exposure in a marine environment for 30 years. In that time tiles have been removed from a roof at 8, 15, 20, 25, 30 and 36 years. The substrates Aluminium Zinc coating has been analysed, after 25 years the projected life expectancy was 75 years, however after 36 years the level of Aluminium Zinc remaining had not deteriorated any further than the 25 year sample. The roof has out lasted pre-painted Galvanised steel on roofs and accessories next door to this roof which were replaced after 25 years.

Gerard Roofing - 30 year marine site roof exposure location

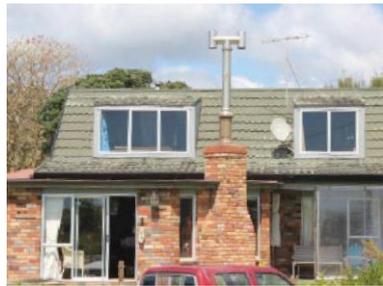
Galvanised nails

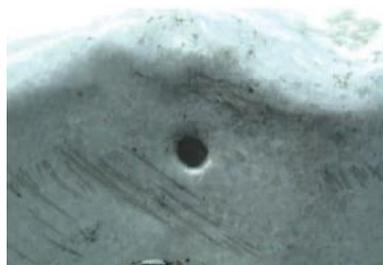
Nail hole

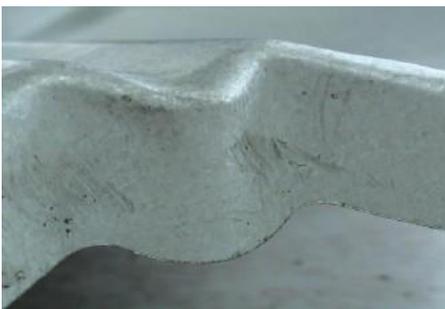
The nose edge

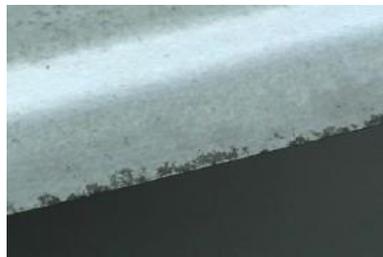
Underside of overlap section edge corrosion
