Chip Loss During Installation

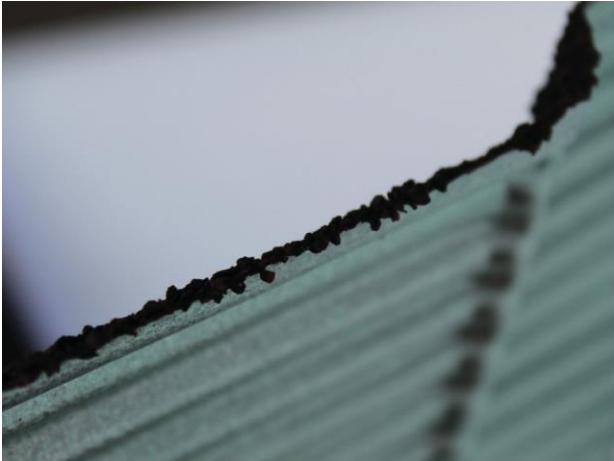
Stone granules at the edge of a tile, this may be removed during installation and handling. This chip may end up being washed down into the gutter.

- There will be a small amount of stone granules lost during the installation process
- The stone granules are applied to the basecoat and then the excess is removed before the tile is coated in overglaze. Granules adhering to the top surface of the tile are strongly bound and will only be removed during installation if the surface is damaged through poor installation technique
- Stone granules that may come loose will have been attached to the edges of the tiles. Basecoat is applied in a thick coating that wraps over the edges of the tiles. Granules that adhere to the basecoat on the edge is only held by a fraction of the granules surface so it is easily knocked off during handling and installation of the tiles

This small amount of chip will eventually be washed down into the rain water gutter. This is the only chip loss that will be seen for many years.
