## Builder's Cladding Location and Gerard Roof Flashings Guide

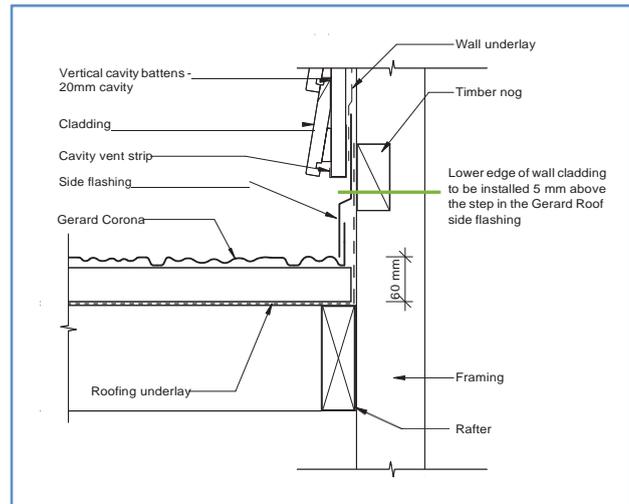
### Correct cladding location

The location above the step of a Gerard flashing is important. The lower edge of the flashing should be installed 5 mm (approximately) above the step in the Gerard flashing.

This allows tiles to be inserted behind the flashings and for future maintenance of the lower edge of the claddings.

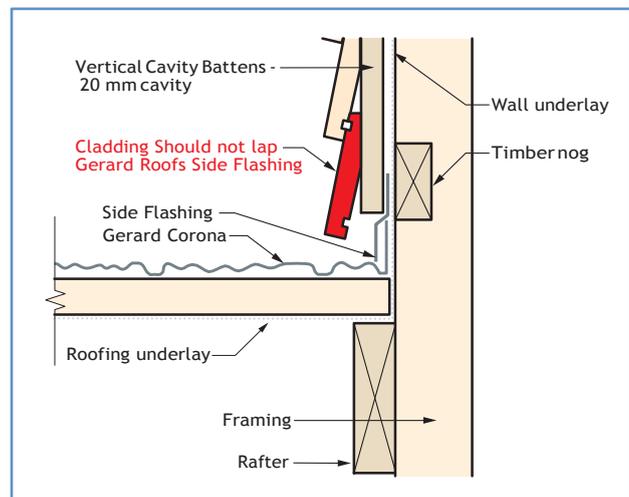
### Incorrect cladding positioning

Positioning as shown is **not suitable for installing any cladding** over a pressed metal tile flashing.
